*Anatolii KLYMENKO, Svetlana KOVALENKO, Vitalii KUZMENKO*

## **CORROSION OF GALVANIZED PIPES IN HOT WATER SYSTEMS**

*E.O. Paton Electric-Welding Institute of the NAS Ukraine  
11, Kazimir Malevich St., Kyiv, 03150, Ukraine. E-mail: Aklimenko@meta.ua*

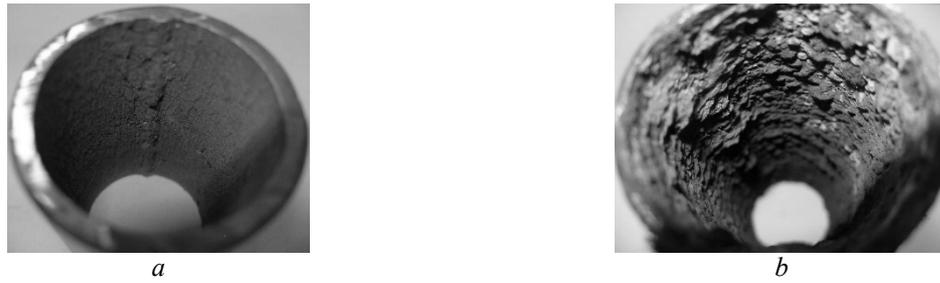
Electric-welded pipes  $\text{Ø}42 \times 3.5$  mm with zinc coating applied to the external and internal surface of the pipe by hot dip galvanizing according to [4-5] in the initial state and after operation pipe in the HWS (Fig. 1), which was dismantled during the emergency repair.

Fig. 1. The galvanized pipe internal surface in the initial state (a) and after operation (b).

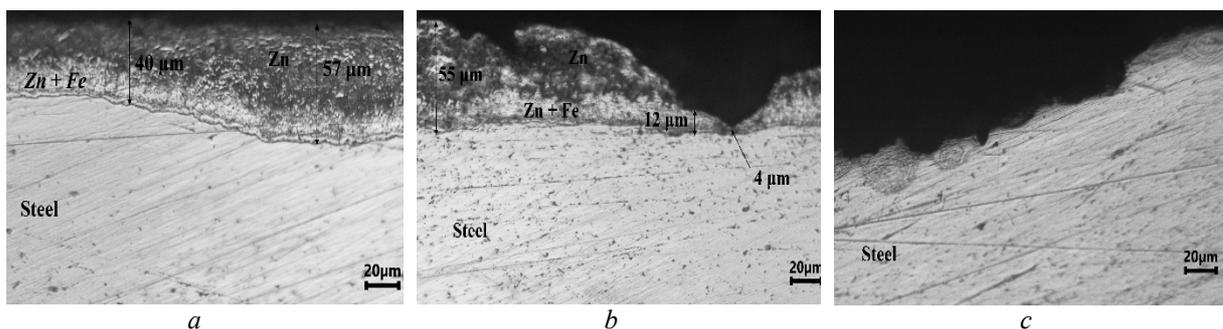
According to the visual inspection of galvanized pipes Ø42×3.5 mm (initial state and after hot water supply system operation) it is established that zinc coating on the outer surface of the pipes, was shiny, smooth and uniform without visible corrosion marks in the both pipes. The initial thickness of the zinc coating on the pipe outer surface ranged from 40 to 57 µm (Fig. 2 a). On the pipe inner surface the thickness of the zinc coating was uneven due to the considerable roughness (Fig. 1a) and ranged from 4 to 55 µm (Fig. 2 b), which was confirmed by the results of the micro-grinding analysis. The pipe inner surface after HWS operation was covered with loose brown color corrosion products (Fig. 1b), after the removal of which the absence of zinc coating was observed on the pipe separate sections, which was confirmed by the microscopic analysis results (Fig. 2c).

Fig.2. Cross-section of zinc coating on the pipe outer wall (a) and on the pipe inner wall (b) in the initial state, and the pipe inner wall after HWS operation (c).

- Zinc coating on the galvanized pipe internal surface in the initial state has a considerable roughness, and its thickness varies in a fairly wide range from 4 $\mu$ m to 55  $\mu$ m, which indicates its low quality.

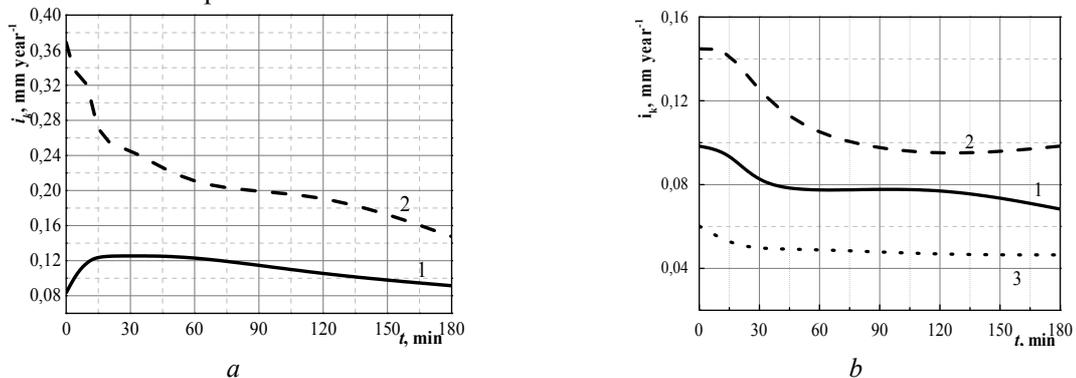
According to the results of measuring the corrosion rate of steel (Fig. 3 a) and zinc coating (Fig. 3 b), it is found that increasing the water temperature from 20 °C to 60 °C, increases the steel corrosion rate by about 2 times from 0.09 mm year<sup>-1</sup> to 0.148 mm year<sup>-1</sup> after 3 hours of measurement. On the zinc coating, with increasing water temperature from 20 °C to 60 °C, the corrosion rate increases from 0.068 mm year<sup>-1</sup> to 0.099 mm year<sup>-1</sup>. Repeated measurement of the corrosion rate of zinc at 20 °C after 3 hours at 60 °C showed a further decrease in the zinc corrosion rate to 0.048 mm year<sup>-1</sup>, which can be explained by the formation of passive zinc hydroxide film. The latter is a negative factor that can lead to both partial and complete passivation of the zinc coating and the loss of its protective properties towards to steel.

Fig.3. Corrosion rate of steel (a) and on zinc (b) obtained with polarization resistance methods in water after water treatment at 20 °C (1), 60 °C (2) and at 20 °C after holding at 60 °C (3).

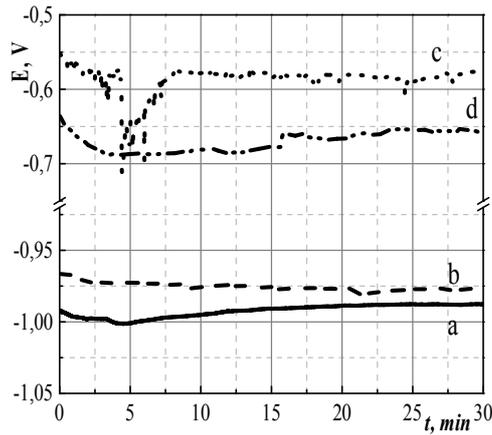
In Fig. 4 shows the results of measuring the corrosion potentials on the outer and inner surfaces and base metal of the galvanized pipe in the initial state, as well as on the zinc coating and base metal (corrosion defect) of the pipe inner surface after operation. As can be seen in Fig.4, the corrosion potential of the pipe outer surface -0.987 V (Fig. 4 a) and the inner ones -0.976 V (Fig. 4 b), i.e. they correspond to the standard potential of zinc, and the potential of the base metal -0.576 V (Fig. 4 c) corresponds to the corrosion potential of steel. On the pipe inner surface after the operation and removal of loose corrosion products, the corrosion potential -0.657 V (Fig. 4 d), which is more negative than steel, but much lower than the supply zinc potential, which can be explained by the significant passivation of the zinc coating. That is, it is confirmed the assumption of the loss of the protective properties of the zinc coating.

Fig.4. Corrosion potential of galvanized pipe on external (a) and inner (b) surfaces, base metal (c) in the initial state and inner surface after operation (d).

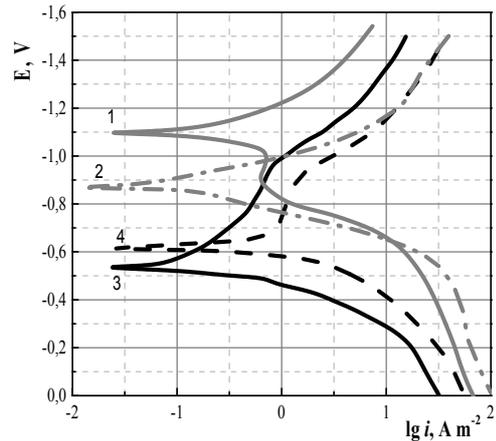
As can be seen in Fig. 5, according to the obtained polarization curves with increasing water temperature from 20°C to 60°C, the zinc coating stationary potential shifts to the anode region from -1.1 V to -0.87 V, with the speed of cathodic processes of reduction from oxygen water and hydrogen, are projected to accelerate approximately 10 times. On the anode curve at 20°C, the zinc passivation region is observed in the anode polarization region from -1.0 V to -0.9 V, with the subsequent transition to the active dissolution region. At a temperature of 60°C, the transition of zinc to the passive state at anode polarization is not observed.

Fig.5. Current-voltage polarization curves of zinc coating (1, 2) and steel base metal (3, 4) of galvanized pipe at 20 °C (3), 60 °C (2, 4).

Increasing temperature promotes the shift of the stationary potential on the pipe base metal into the cathode region from -0.54 V at 20 °C to -0.62 V at 60 °C. In addition, as the temperature increases, acceleration of both cathodic (oxygen and hydrogen reduction) and anode processes (steel dissolution) is predicted.
